Aerial and Assessor Parcel
3201 & 3061 Napa Rd
Sonoma, CA 95476

WELL TESTING SERVICE

REPORT #: 7797-2 By: Matt Owens	DATE OF TEST: 12/28/15
CUSTOMER NAME: Black Trust	CONTACT: Kyle Orth - 559 437 7648
AGENT NAME: Eric Frost - Century 21 Bundesen	CONTACT: 707 484 1292
PROPERTY ADDRESS: 3201 Napa Rd, Sonoma CA 95476	SENT TO: eric.frost@bundesen.com

LOCATION OF WELL:	Main Well - To right of driveway in field near gate entrance
TYPE OF WELL:	Drilled
DEPTH OF COMPLETED WELL:	785 Feet - as indicated by provided drill log
DIAMETER OF WELL CASING:	6" PVC with 8" PVC stub at surface
SANITARY WELL SEAL (PLATE SEAL AT OPENING OF WELL CASING):	Yes
ANNULAR SEAL (IN-GROUND SEAL OF BOREHOLE):	38' cement seal
PUMP HP AND TYPE:	10 HP 230V 3PH Submersible, 2.5" tee, #4-3 cable
DEPTH OF PUMP SUCTION:	Unknown - please refer to installer records

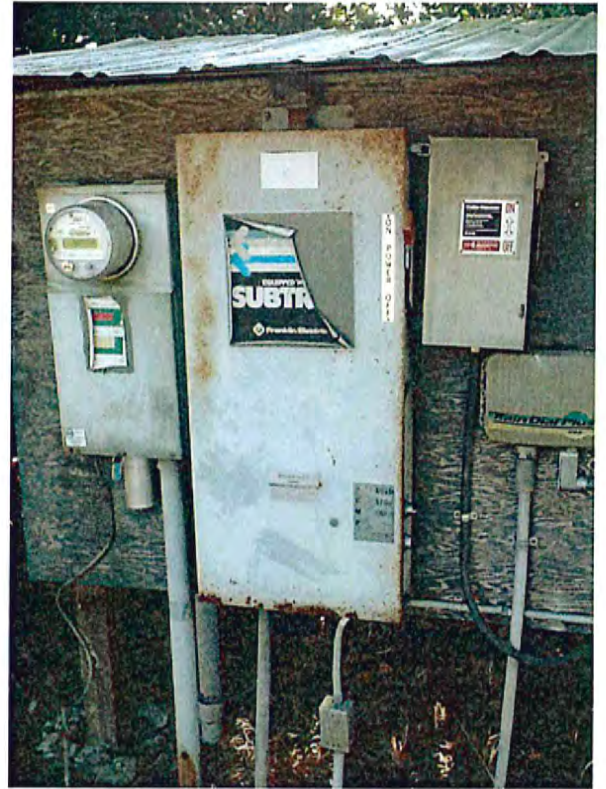
Well Pump Control Panel

WELL PUMP	Functional	TECHNICAL INFO: Control panel dated 1985, 12.4 amps
ELECTRICAL	Functional	TECHNICAL INFO: 70 amp fuse disconnect in control panel
PRESSURE TANK	See Comments	TECHNICAL INFO: See Comments
STORAGE TANK	None	TECHNICAL INFO: Pond is used as reservoir
BOOSTER PUMP	Deficient	TECHNICAL INFO: 20 HP 460V 3PH Cornell 2 1/2 W20-2 booster pump, 135 amps

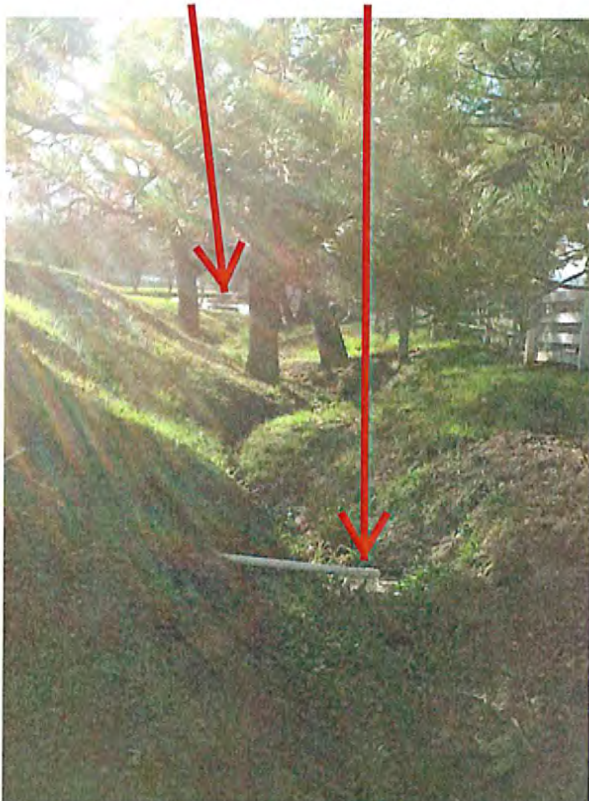
Pond / Pond Fill Pipe

1. The recharge rate at the end of the test was 45 gallons per minute. This test may not represent the long term or seasonal yield.
2. This well is only used to fill the pond located on the property. There is a pipe protruding from the creek bank adjacent to the well and this is the only outlet pipe from the well. The pump is operated manually when needed.
3. There is a 20 HP 460V 3 Phase booster pump that draws water from the pond and pressurizes 2 - WX-350 pressure tanks dated 1989 with 0 and 42 psi air charges. The operating pressure range could not be determined as the pump was not functional. This system (when functional) pressurizes water for sprinklers at the various arenas on the property. The pump drew 135 amps, indicating a locked rotor.
4. There is a 4" Morrill 1000 series model 1010 horizontal filter installed on the main line leaving the booster pump.

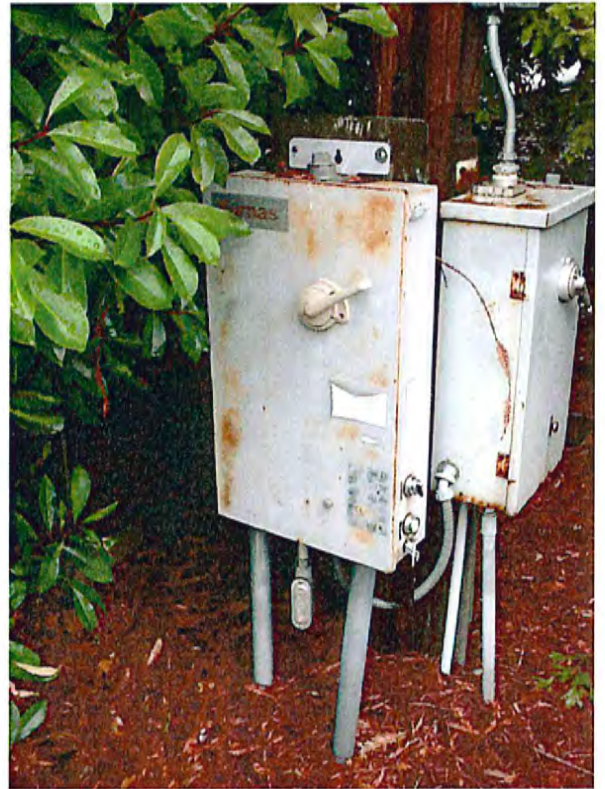
Well Pump Control Panel

WELL PUMP	Functional	TECHNICAL INFO: 50.7 GPM @ 100 PSI @ 266', 32.2 amps, sticker dated 1986
ELECTRICAL	Functional	TECHNICAL INFO: 50 amp 3 pole breaker in pump control panel
PRESSURE TANK	Functional	TECHNICAL INFO: see comments
STORAGE TANK	Functional	TECHNICAL INFO: 2500 gallon poly tank - fire protection only.
BOOSTER PUMP	None	TECHNICAL INFO:

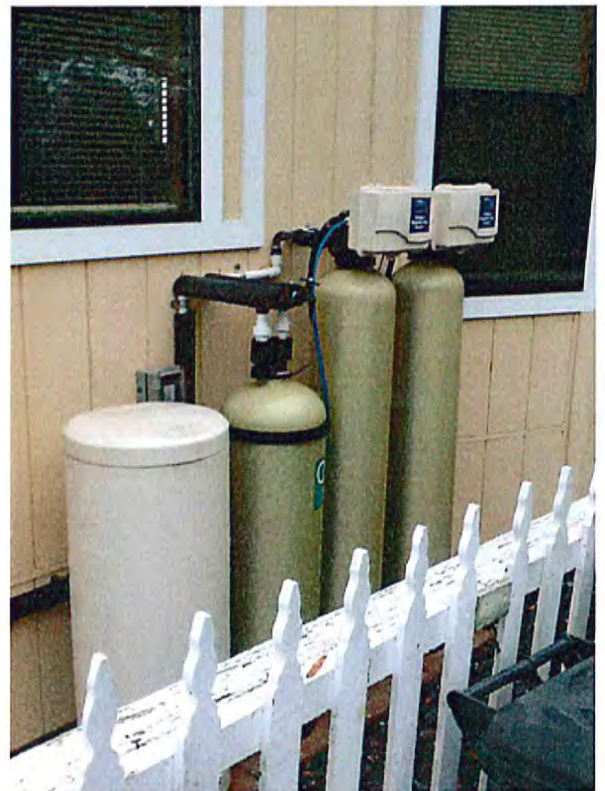
Caretaker Unit Treatment System

6. The caretaker unit treatment system includes a 10" x 54" Culligan Medallist media filter (media unknown, no plug to check level), a 10" x 54" Culligan Medallist water softener (brine tank 1/2 full), and a 12" x 42" media filter (no backwash valve).

1. There is a valve that isolates the well pump from the pressure tank manifold. Recommend removing valve or locking handle to prevent accidental damage to pump.
2. The treated water at the main house tested acidic. Recommend contacting installer for repairs or additional equipment.
3. Arsenic was detected above the drinking water from the sample take direct from the well. Another sample was drawn post treatment at the main house indicates it was not detected. Recommend routine testing downstream of the equipment to determine when service is necessary to maintain a safe level. Recommend testing downstream of the other units at the poolhouse and caretaker house.

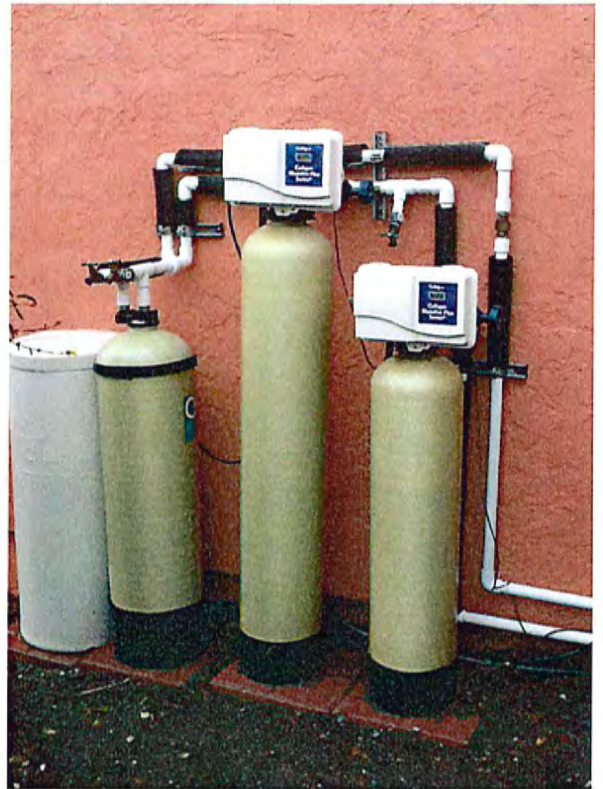
Poolhouse Treatment System

7. The pool house treatment system includes a 10" x 42" Culligan medallist plus media filter (media unknown, no plug to check level), a 10" x 54" Culligan medallist plus water softener (brine tank 1/2 full), and a 12" x 42" media filter (no backwash valve).

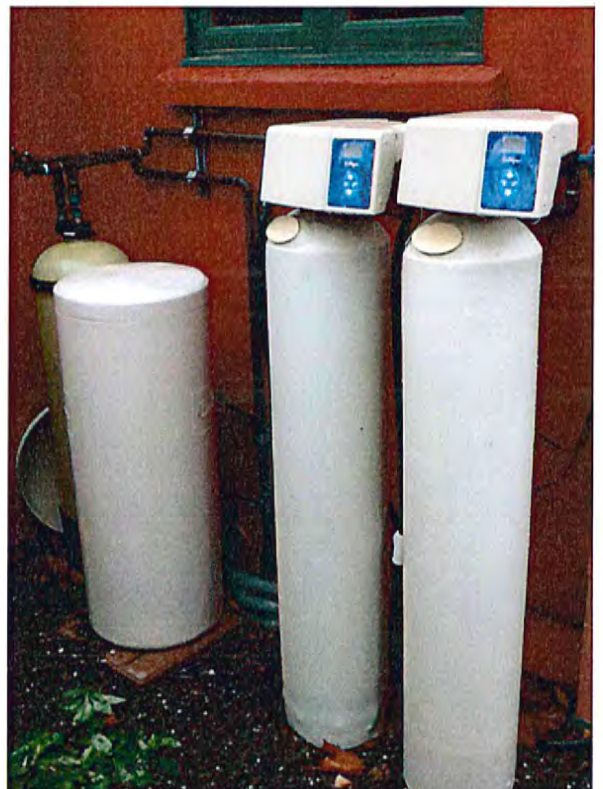
Main House Treatment System

8. The main house water treatment system includes a 10" x 54" Culligan media filter (media unknown, level not visible), a 10" x 54" Culligan water softener (brine 1/2 full), and a 12" x 42" media filter (no backwash valve).

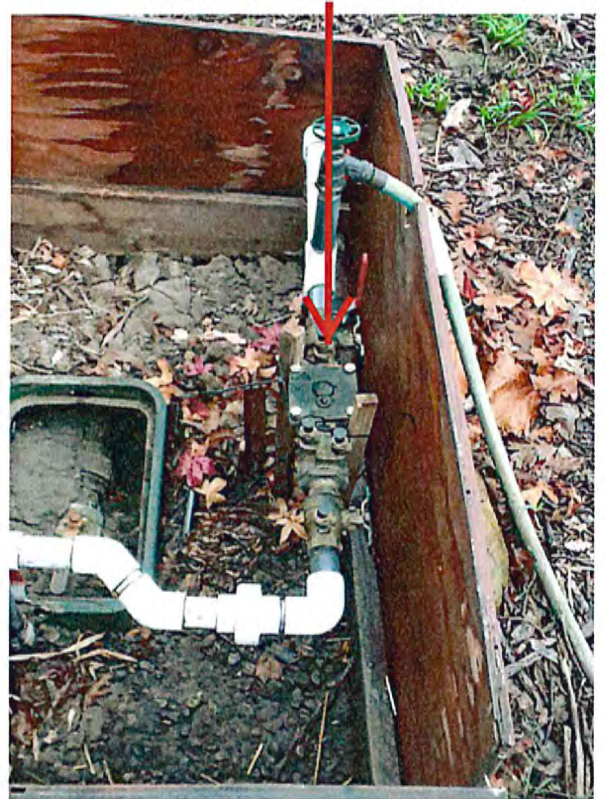
Irrigation RP Check Valve

9. There is a 1" Watts RP check valve on the landscape irrigation main to prevent siphoning of irrigation water.
