WELL TESTING SERVICE

REPORT #: 7797-1 By: Matt Owens	DATE OF TEST: 12/21/15
CUSTOMER NAME: Black Trust	CONTACT: Kyle Orth - 559 437 7648
AGENT NAME: Eric Frost - Century 21 Bundesen	CONTACT: 707 484 1292
PROPERTY ADDRESS: 3201 Napa Rd, Sonoma CA 95476	SENT TO: eric.frost@bundesen.com

WATER SYSTEM INSPECTION

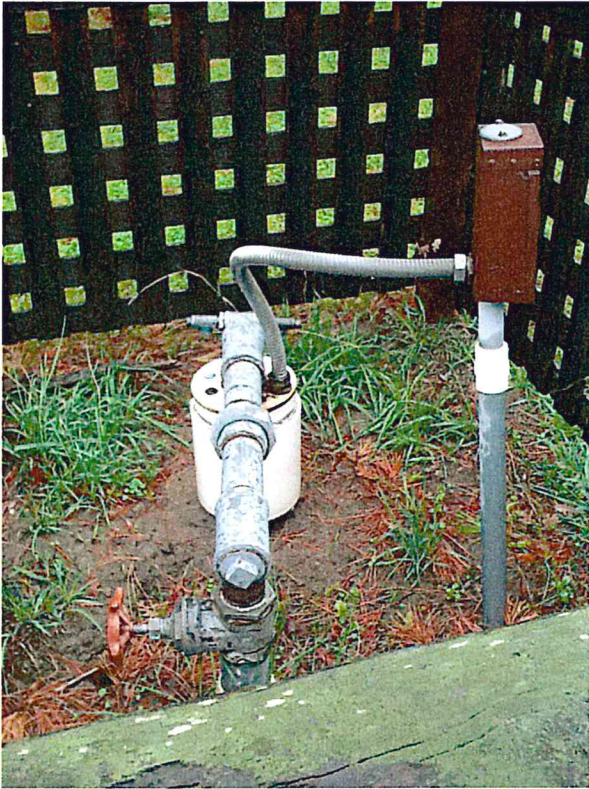
Well Head

LOCATION OF WELL:	Main Well - To right of driveway in field near gate entrance
TYPE OF WELL:	Drilled
DEPTH OF COMPLETED WELL:	785 Feet - as indicated by provided drill log
DIAMETER OF WELL CASING:	6" PVC with 8" PVC stub at surface
SANITARY WELL SEAL (PLATE SEAL AT OPENING OF WELL CASING):	Yes
ANNULAR SEAL (IN-GROUND SEAL OF BOREHOLE):	38' cement seal
PUMP HP AND TYPE:	10 HP 230V 3PH Submersible, 2.5" tee, #4-3 cable
DEPTH OF PUMP SUCTION:	Unknown - please refer to installer records

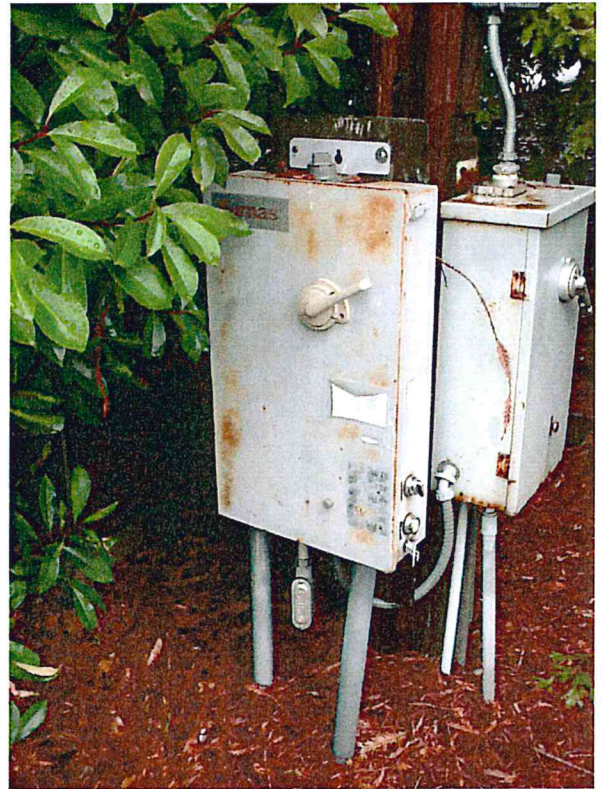
Well Pump Control Panel

WELL PUMP	Functional	TECHNICAL INFO: 50.7 GPM @ 100 PSI @ 266', 32.2 amps, sticker dated 1986
ELECTRICAL	Functional	TECHNICAL INFO: 50 amp 3 pole breaker in pump control panel
PRESSURE TANK	Functional	TECHNICAL INFO: see comments
STORAGE TANK	Functional	TECHNICAL INFO: 2500 gallon poly tank - fire protection only.
BOOSTER PUMP	None	TECHNICAL INFO:

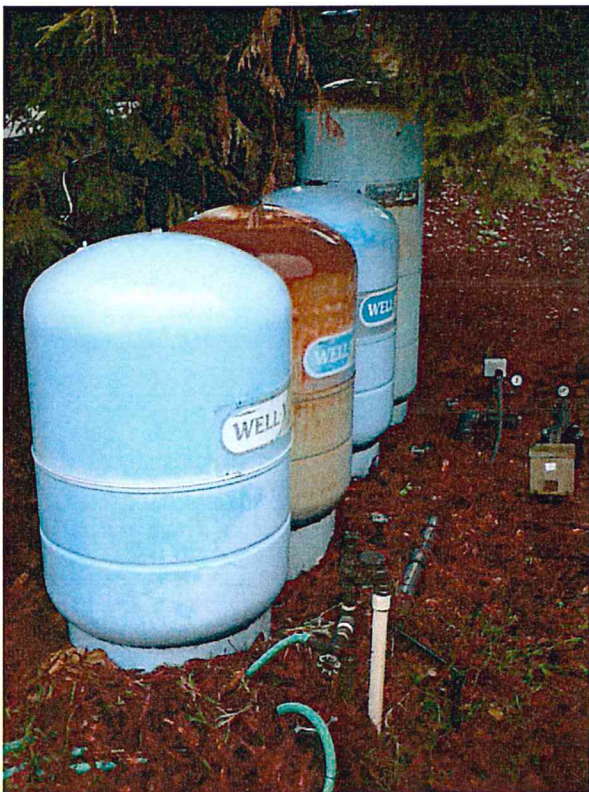
Pressure Tanks

4. The water was odor free for the duration of the test.
5. The well pump pressurizes 3- 86 gallon WX-302 pressure tanks dated 1990, 1987, and 1988 with 27, 30, and 30 psi air charges and 1-86 gallon WX-252 pressure tank dated 1977 with a 28 psi air charge. The operating pressure range is set 42 to 65 psi. This system pressurizes water for domestic use at the caretaker unit, pool house and main house. It also fills the fire storage tank and serves all landscape irrigation.

9. There is a 1" Watts RP check valve on the landscape irrigation main to prevent siphoning of irrigation water.
Recommendations:
1. There is a valve that isolates the well pump from the pressure tank manifold. Recommend removing valve or locking handle to prevent accidental damage to pump.

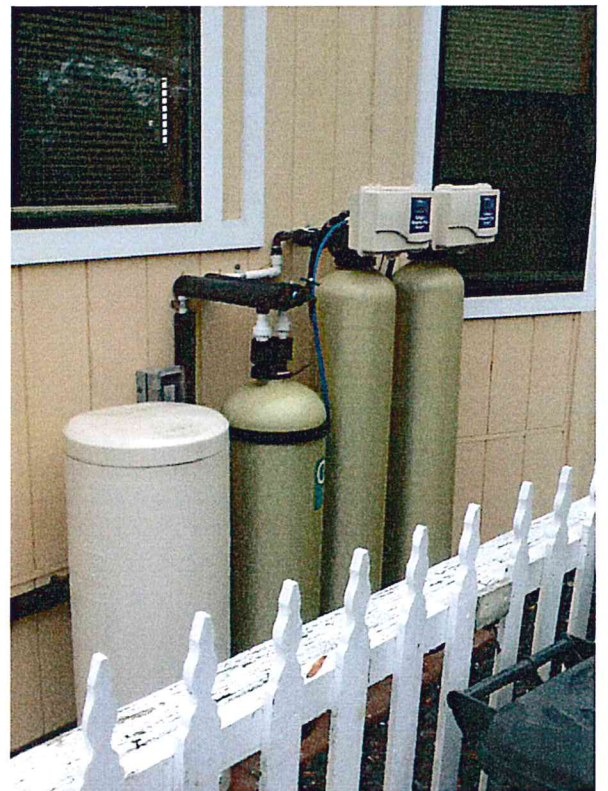
Caretaker Unit Treatment System

6. The caretaker unit treatment system includes a 10" x 54" Culligan Medallist media filter (media unknown, no plug to check level), a 10" x 54" Culligan Medallist water softener (brine tank 1/2 full), and a 12" x 42" media filter (no backwash valve).

2. The treated water at the main house tested acidic. Recommend contacting installer for repairs or additional equipment.
3. Arsenic was detected above the drinking water from the sample take direct from the well. Another sample was drawn post treatment at the main house indicates it was not detected. Recommend routine testing downstream of the equipment to determine when service is necessary to maintain a safe level. Recommend testing downstream of the other units at the poolhouse and caretaker house.

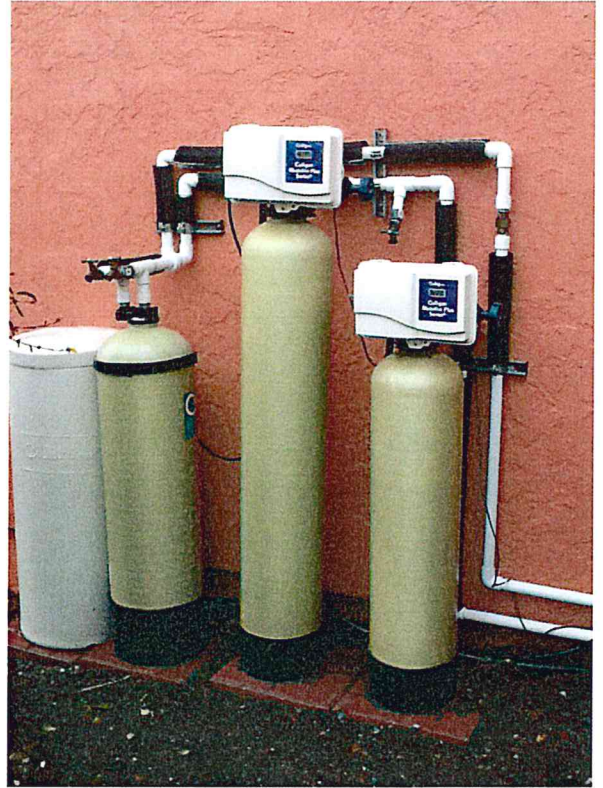
Poolhouse Treatment System

7. The pool house treatment system includes a 10" x 42" Culligan medallist plus media filter (media unknown, no plug to check level), a 10" x 54" Culligan medallist plus water softener (brine tank 1/2 full), and a 12" x 42" media filter (no backwash valve).

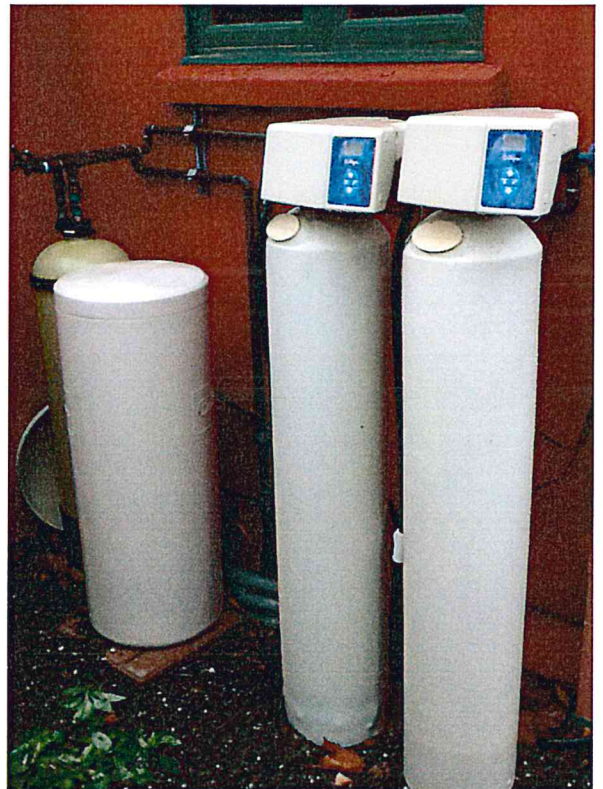
Main House Treatment System

8. The main house water treatment system includes a 10" x 54" Culligan media filter (media unknown, level not visible), a 10" x 54" Culligan water softener (brine 1/2 full), and a 12" x 42" media filter (no backwash valve).
